CCF Yard, Machynlleth
Demolition and Site Re-development
Preliminary Ecological Survey

25th June 2018

Report by: Kate Williamson CIEEM:
Client: George & Tomos Architects, 12 Heol Penrallt, Machynlleth, Powys
Planning Authority: Powys County Council
Grid Reference: SH 74964 00798

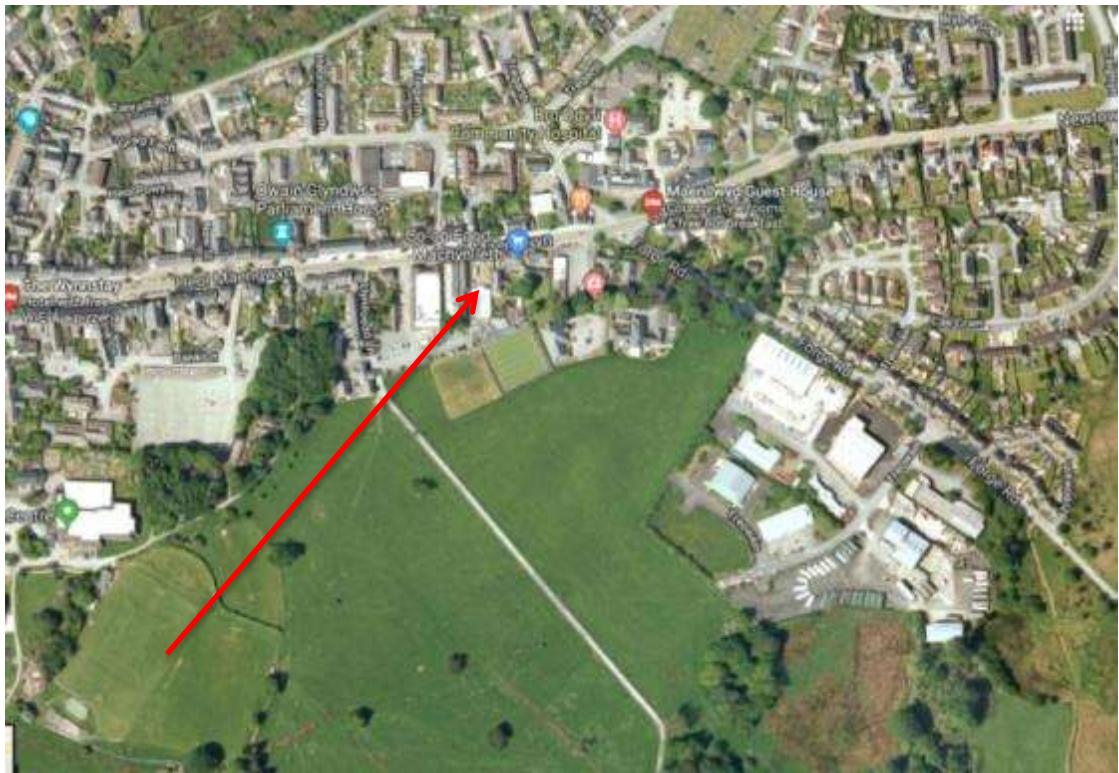
Fig.2: Location of CCF yard within Machynlleth and surrounding habitats

The CCF yard is situated within the town centre of Machynlleth and surrounded by urban development. However, there are some heavily managed, amenity areas immediately to the south of the site, with grazed fields further away. There are high levels of lighting affecting the front half of the site from street lighting and security lighting in both adjacent lots.

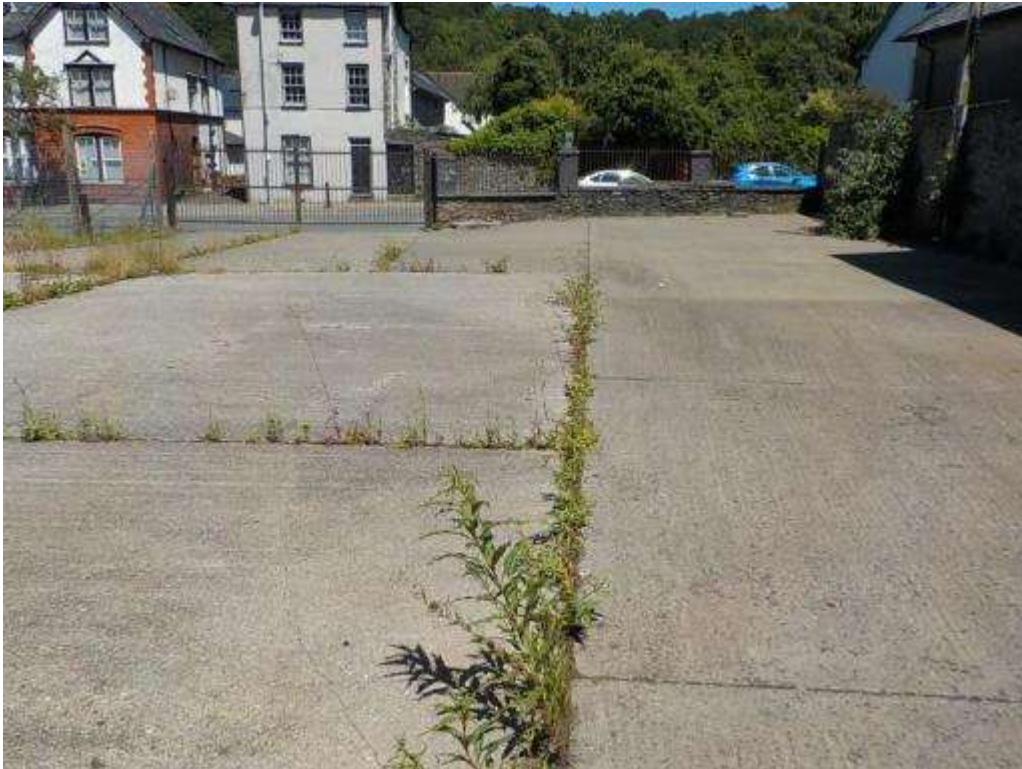
Area of hard standing at the north of the site, in front of the large shed

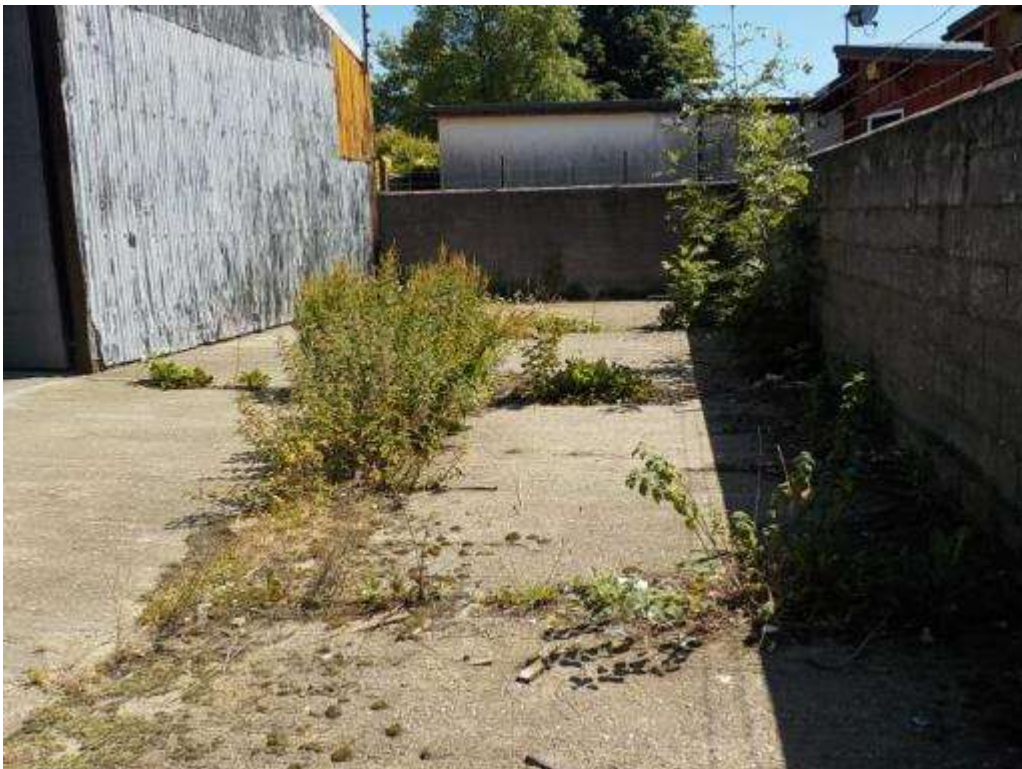
Area of hard standing to the rear of the shed, south of the site

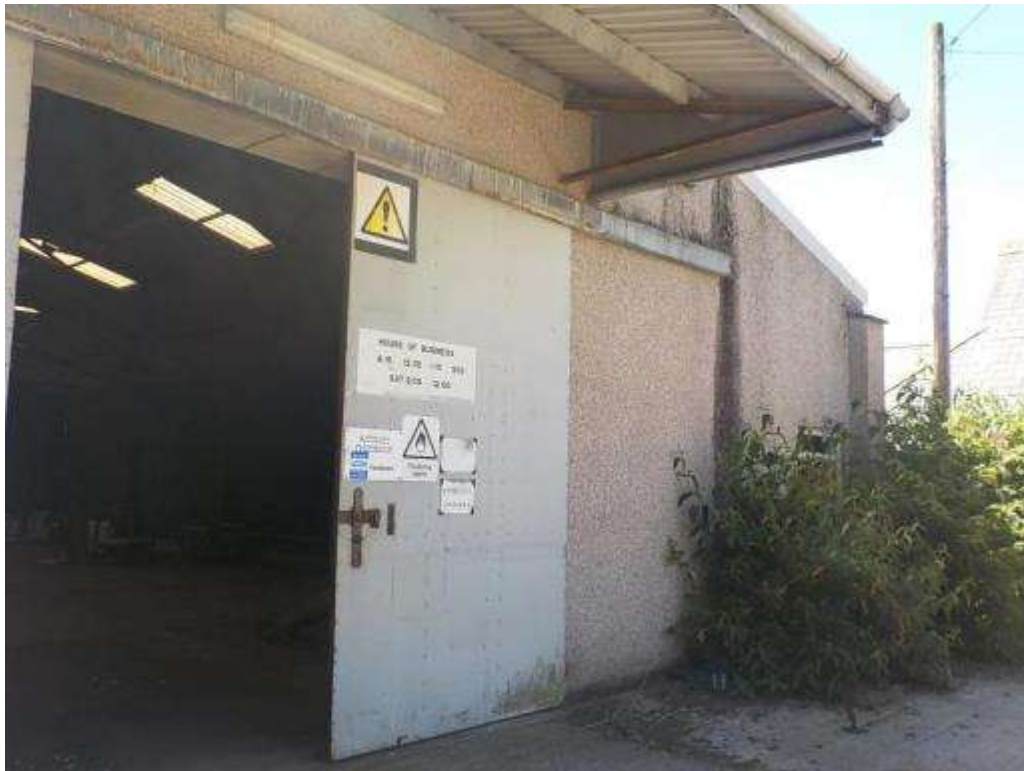
The main building on the site is a large, corrugated metal, agricultural shed. The roof and walls are sheets of corrugated metal and the building is constructed on a steel frame. The front elevation has very large double doors and a block construction. This elevation is pebble-dashed and there are no crevices in the block work. The metal barge boarding is tight against the wall, with no gap. There are transparent panels within the roof of the shed, giving very high light levels within the interior. There are gaps within the corrugations of the walls, where they are attached to the steel frame. There is potential bat access over the top of the walls.

Front elevation of the shed

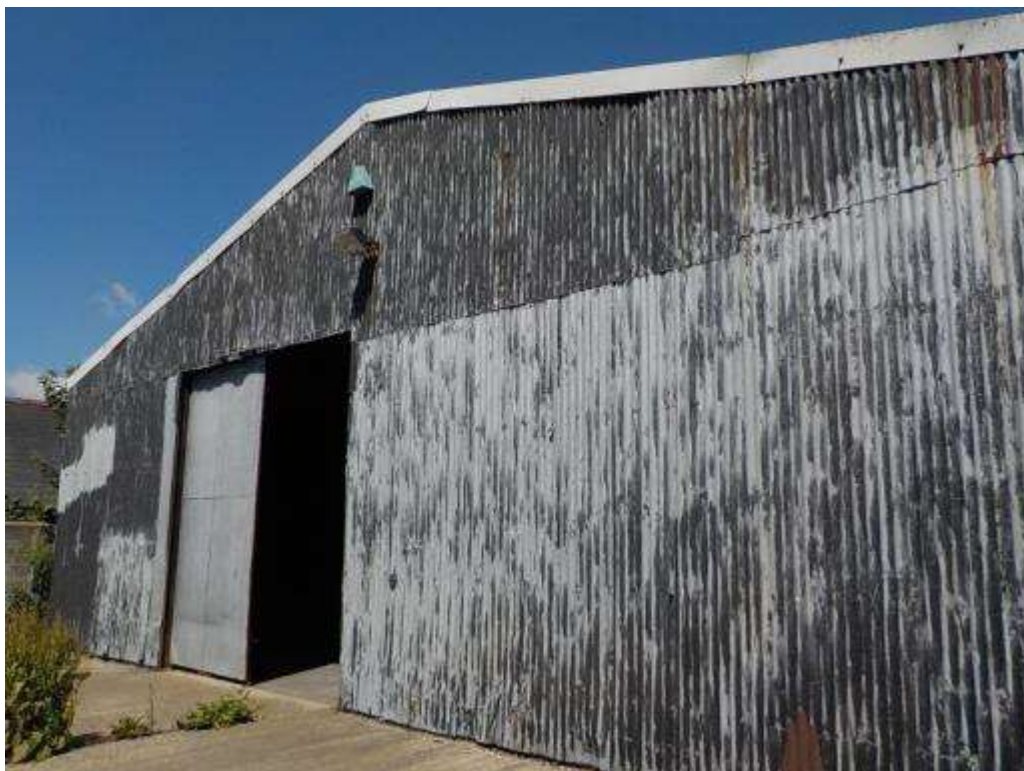
Rear elevation of the shed

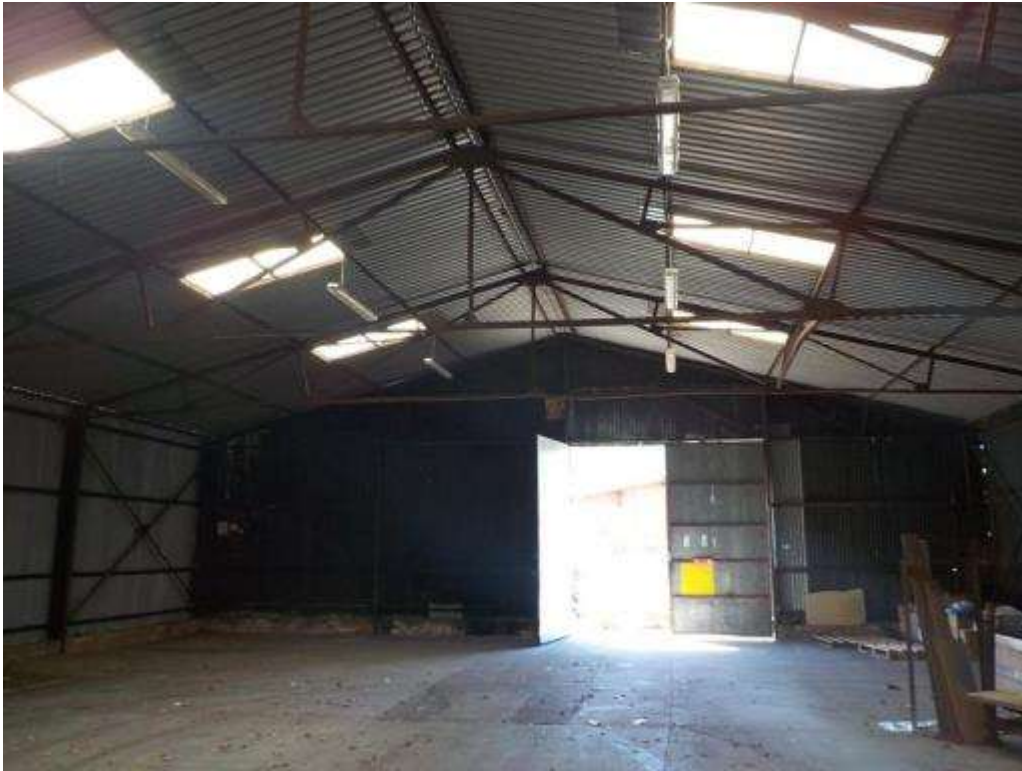
No sign of current or past use by bats was recorded on either the interior or exterior of either of the buildings. There is no apparent access to the toilet block building and minimal roosting potential within features on the metal shed. The only roosting potential present is within corrugations, where the walls are attached to the metal

frame. These areas would be subject to extreme variations in temperature and are not considered suitable for roosting bats.

Interior of the shed

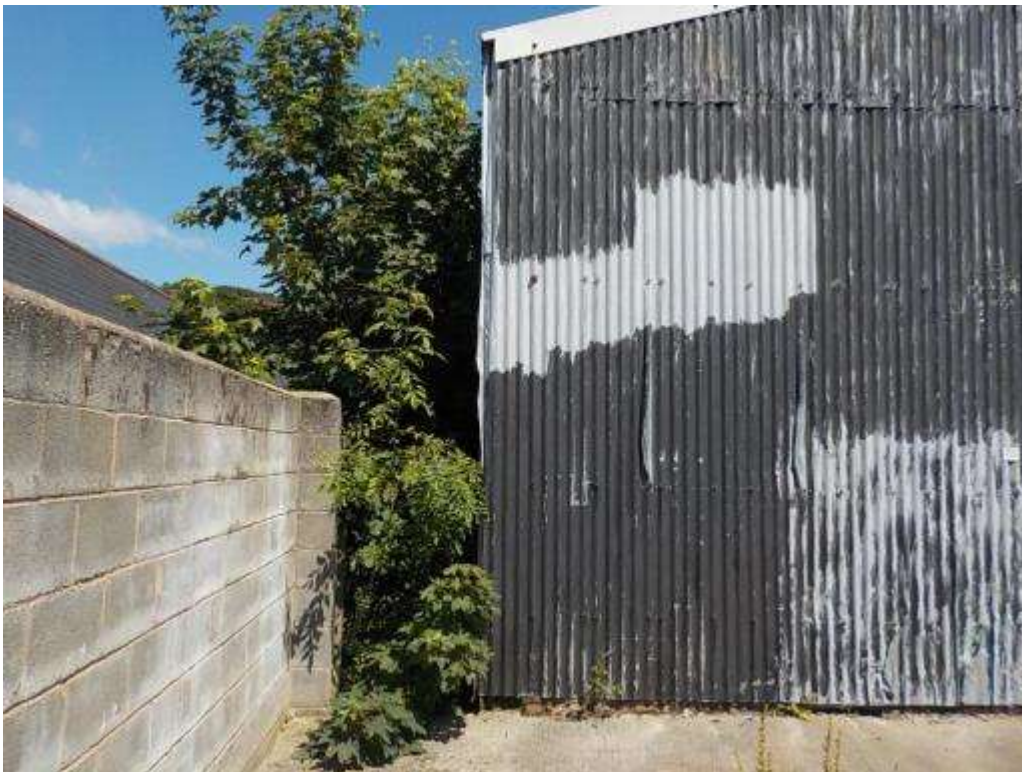
Apart from the hard standing, there are small areas along both sides of the large shed, which have developed some early succession scrub. Species present here are ash (*Fraxinus excelsior*) and sycamore (*Acer pseudoplatanus*) saplings, bramble (*Rubus fruticosus*) and nettles.

There was no sign of any nesting birds associated with the buildings on the site. The small areas of scrub have some limited potential to support nesting birds during the recognised breeding season and some precautionary measures should be taken during the site clearance to avoid any disturbance.

Small areas of scrub between sides of the shed and the site boundary wall

The removal of the scrub vegetation and the demolition of the adjacent buildings should be undertaken outside of the recognised nesting bird season, considered by RSPB to be 1st May to 30th September. If however this is not possible, a thorough search for active nests should be made by a suitably qualified ecologist immediately prior to the works commencing. If any nests are recorded, the works will need to be postponed until such time as any chicks have fledged.

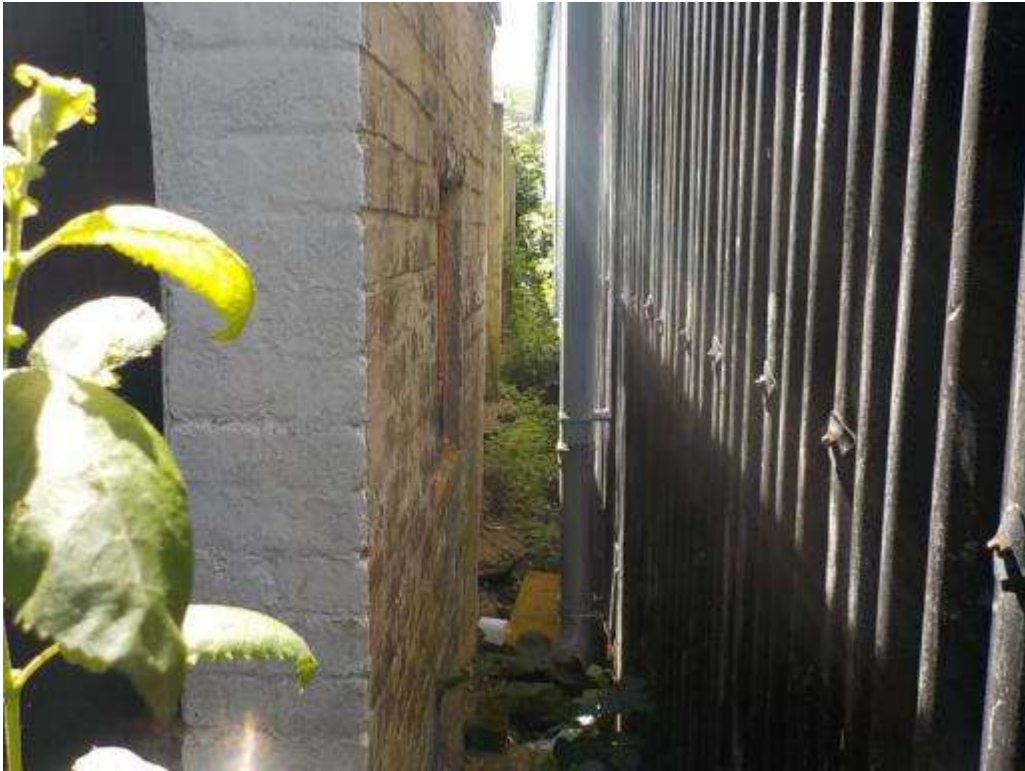
There is a small block building along the Eastern edge of the yard, formally used as the toilets. The block walls also have fascias attached tightly and there is a flat roof. There are no visible crevices suitable for roosting bats and no apparent access to the interior.

Edge of the small toilet block and shed wall

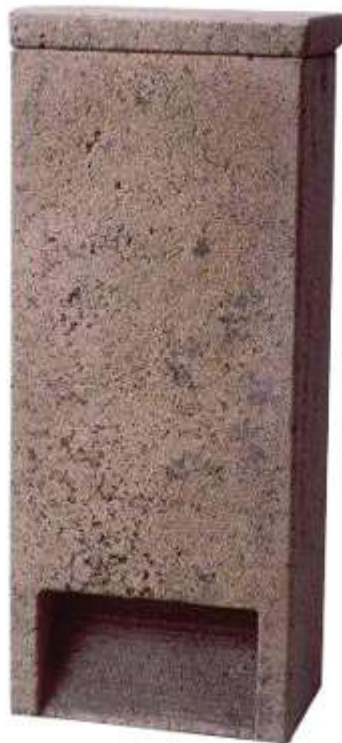
Schwegler 2FR bat tube

- The incorporation of bat bricks or tubes within the fabric of any new dwellings. There are a range of products available, including the Schwegler 2FR bat tube and Schwegler brick box 27, which would be suitable. The inclusion of these potential roost sites increases the roost availability for a range of bat species. The tubes can be built into the fabric of the new development on the south elevation of flats 5, 8, 11 and potentially on the western and eastern elevation of the rear build too. These elevations are subject to the least amount of light pollution from surrounding buildings and street lighting. The tubes must be located as high as possible from the ground to reduce the potential for disturbance and should be shown clearly on the architect's plans.
